Debris/Ice/TPS Assessment and Integrated Photographic Analysis of Shuttle Mission STS-69

Gregory N. Katnik, Barry C. Bowen, J. Bradley Davis

DEBRIS/ICE/TPS ASSESSMENT
AND
INTEGRATED PHOTOGRAPHIC ANALYSIS
OF
SHUTTLE MISSION STS-69

7 September 1995

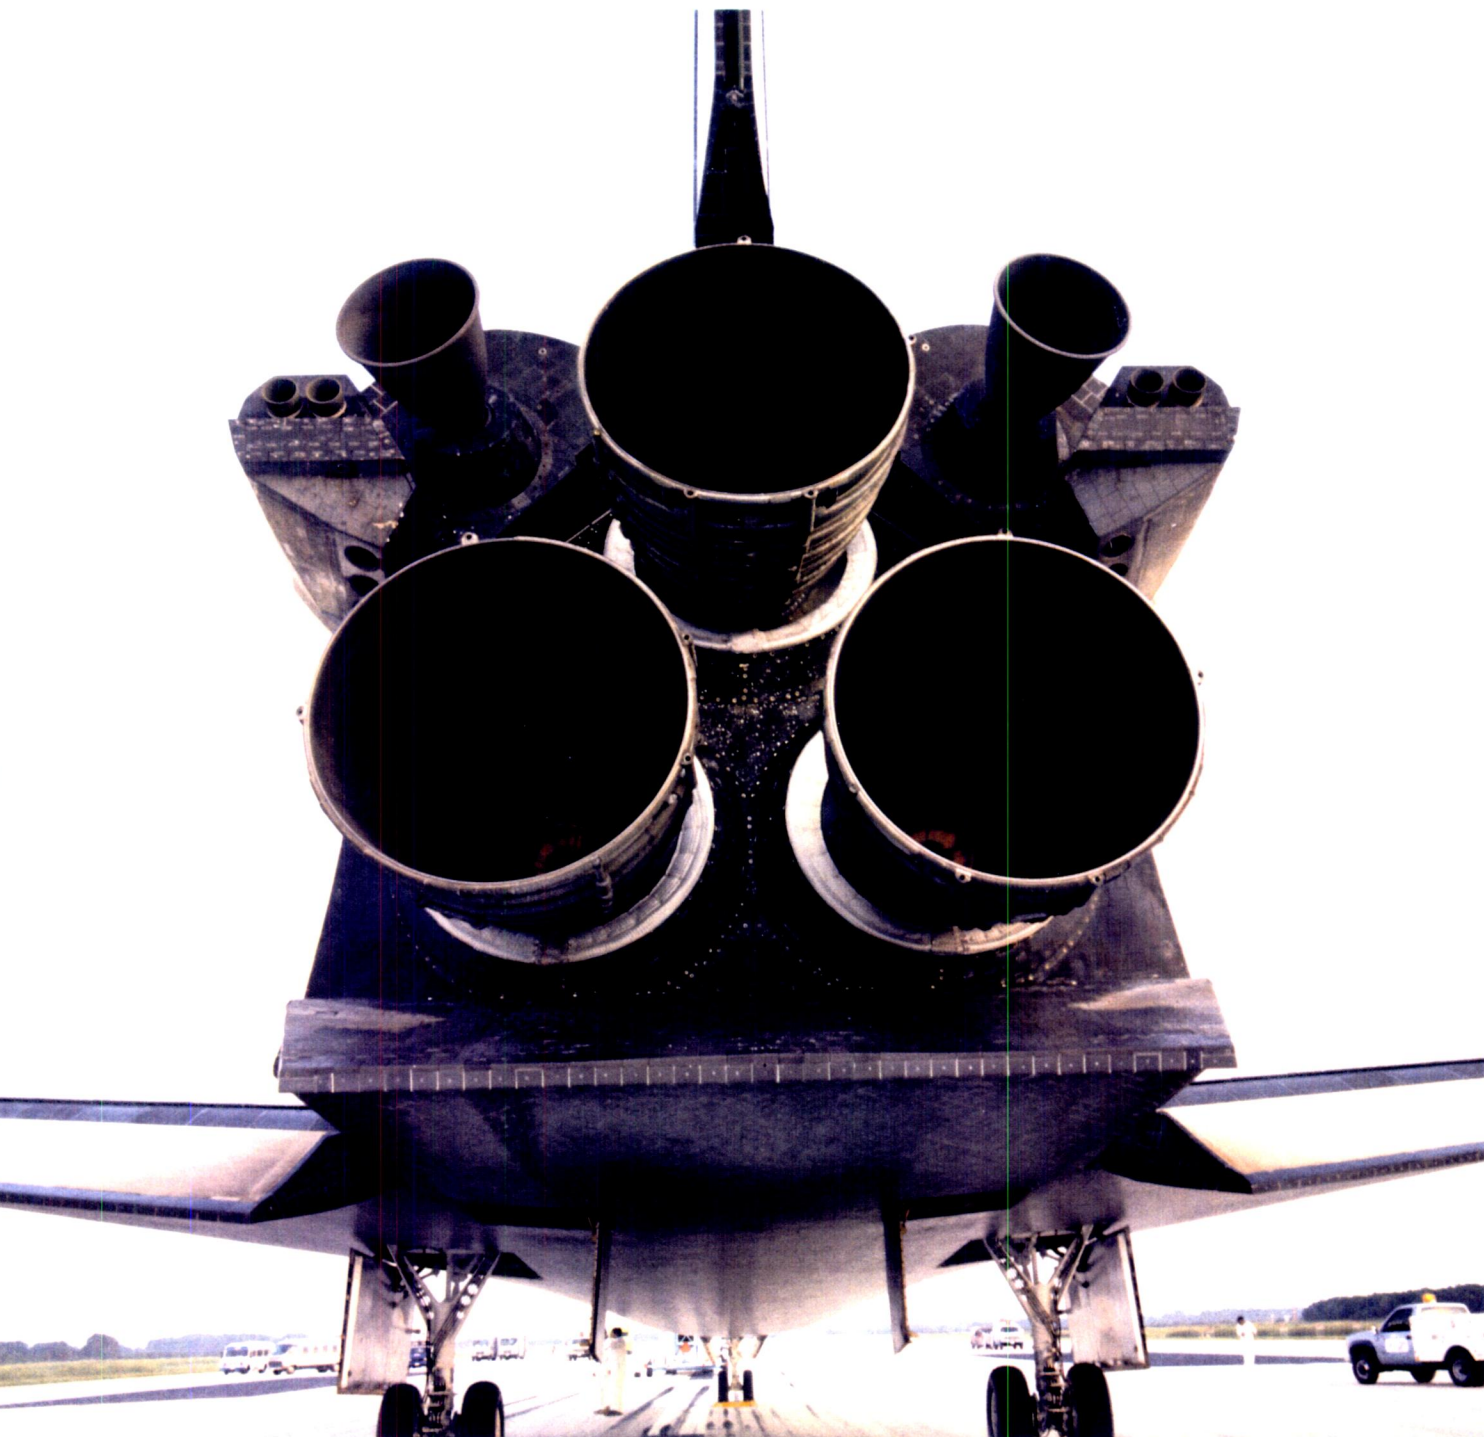
Photo 22 : Base Heat Shield

Overall view of the base heat shield. The SSME Dome Mounted Heat Shield closeout blankets were in good condition.

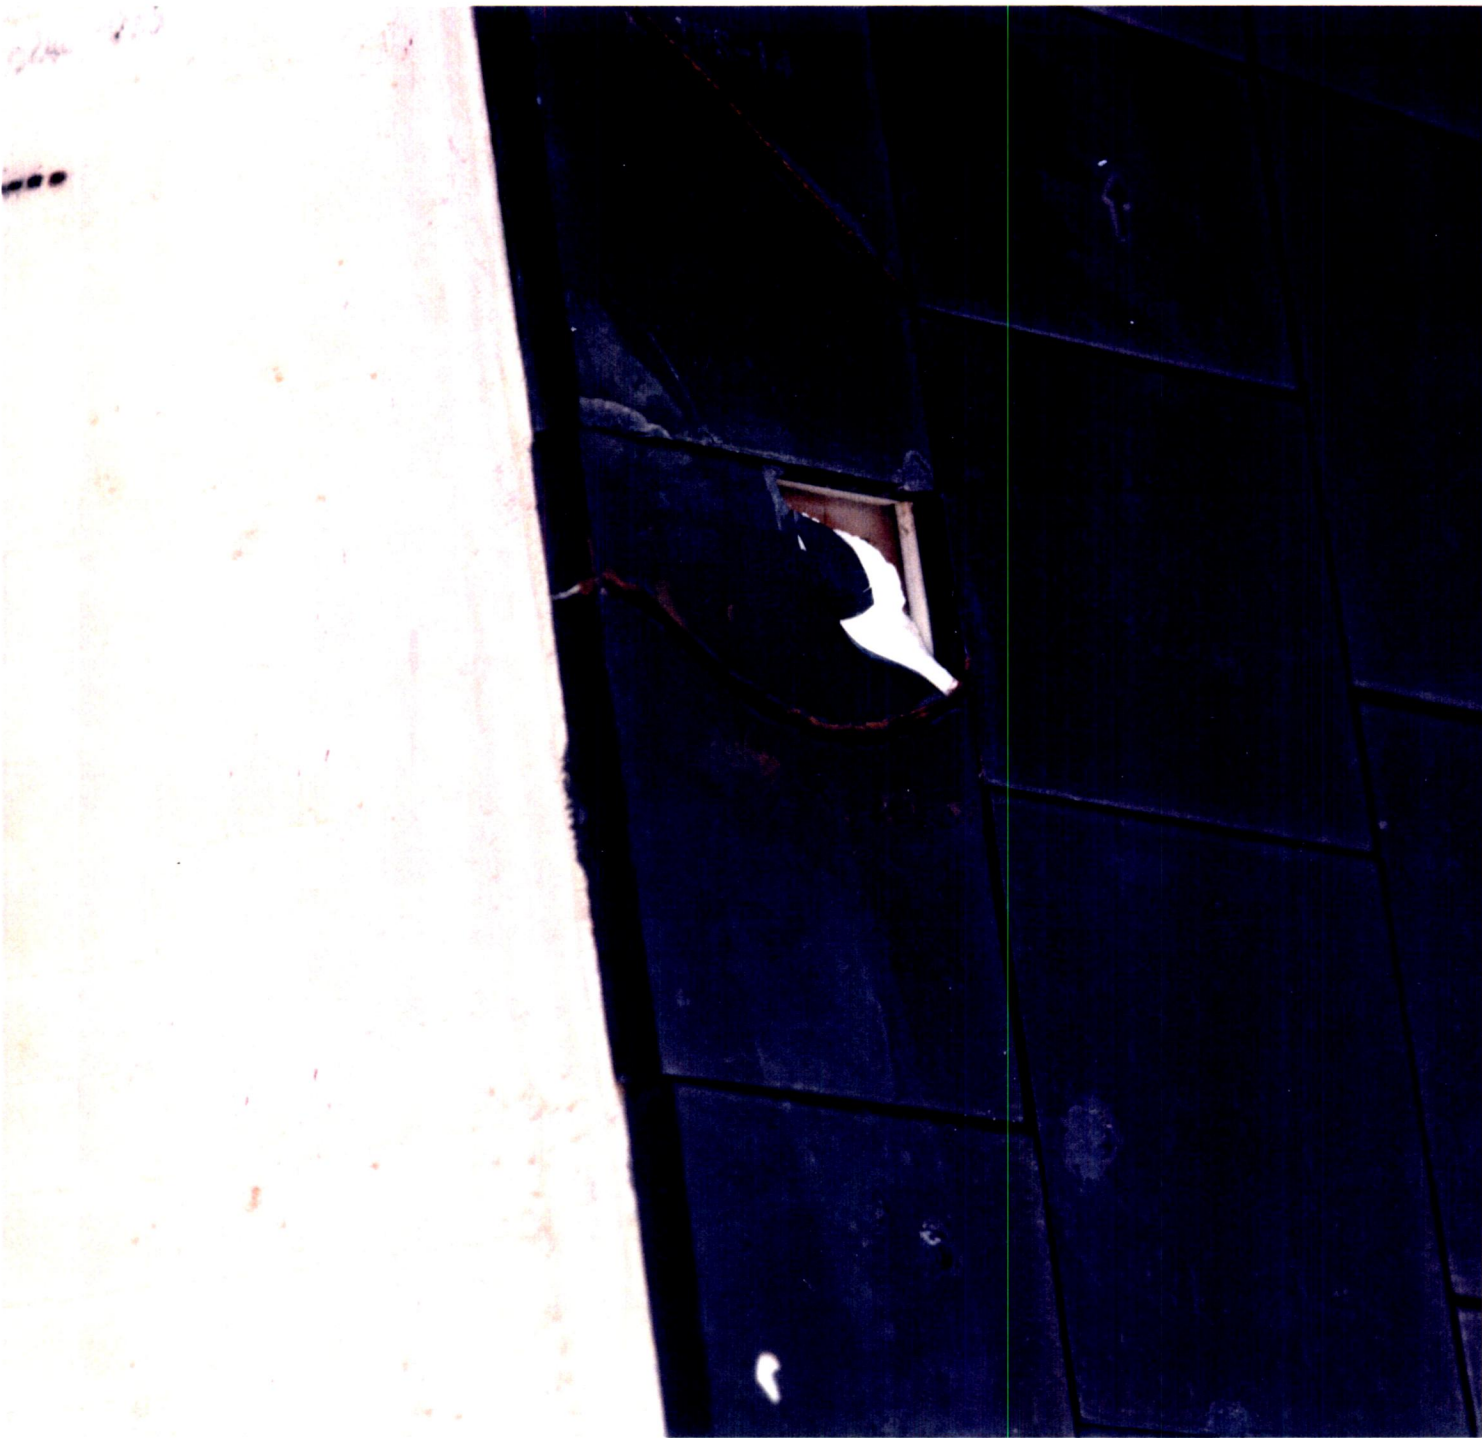
Photo 23 : Loose Tile on Base Heat Shield

A piece of tile, 2.25-inches long by 2-inches wide by 5/8-inch thick was loose on the base heat shield outboard of SSME #2. The filler bar was exposed when the loose piece was removed.

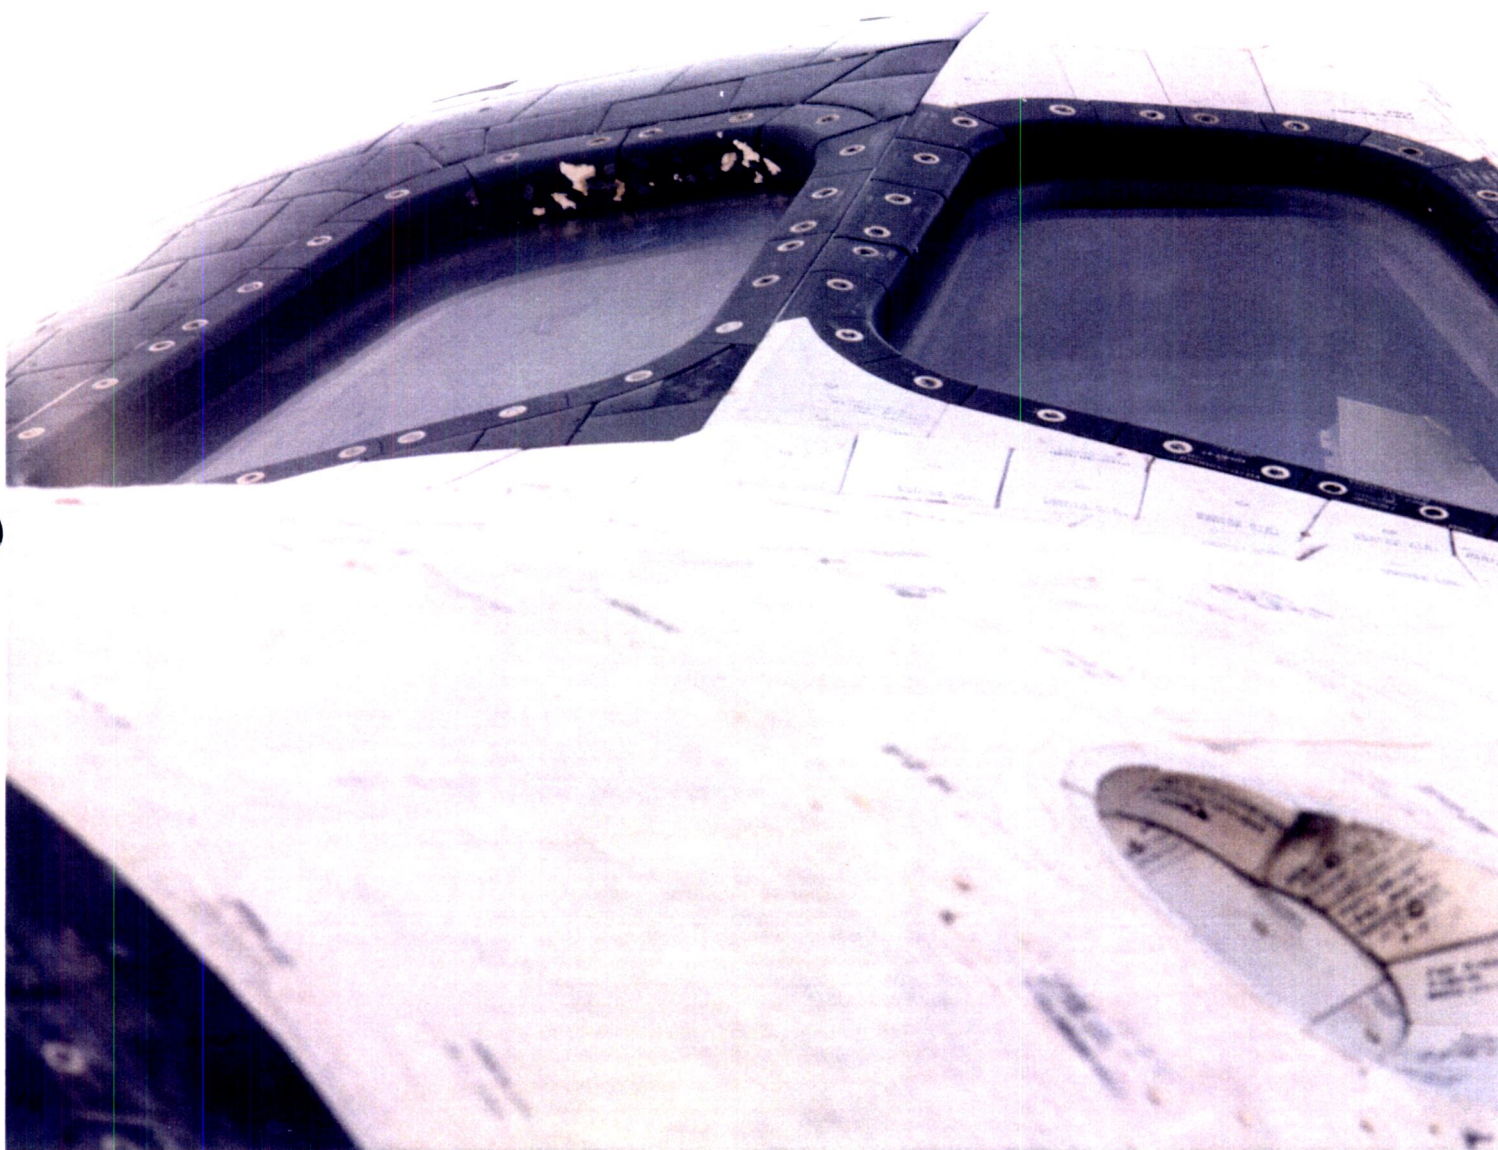
Photo 24 : Orbiter Windows

Tile damage on the window perimeter tiles was concentrated above window #3. The 11 tile damage sites in this area were probably caused by impacts from FRCS paper cover pieces and RTV. A large damage site on a window #5 perimeter tile and two damage sites in the space between windows #3 and #4 were also noted.

Orbiter windows #3 and #4 exhibited moderate hazing and streaking. A light haze was present on the other windows. Tile damage on the window perimeter tiles was concentrated above window #3. The 11 tile damage sites in this area were probably caused by impacts from FRCS paper cover pieces and RTV. Two damage sites in the space between windows #3 and #4 were also noted.

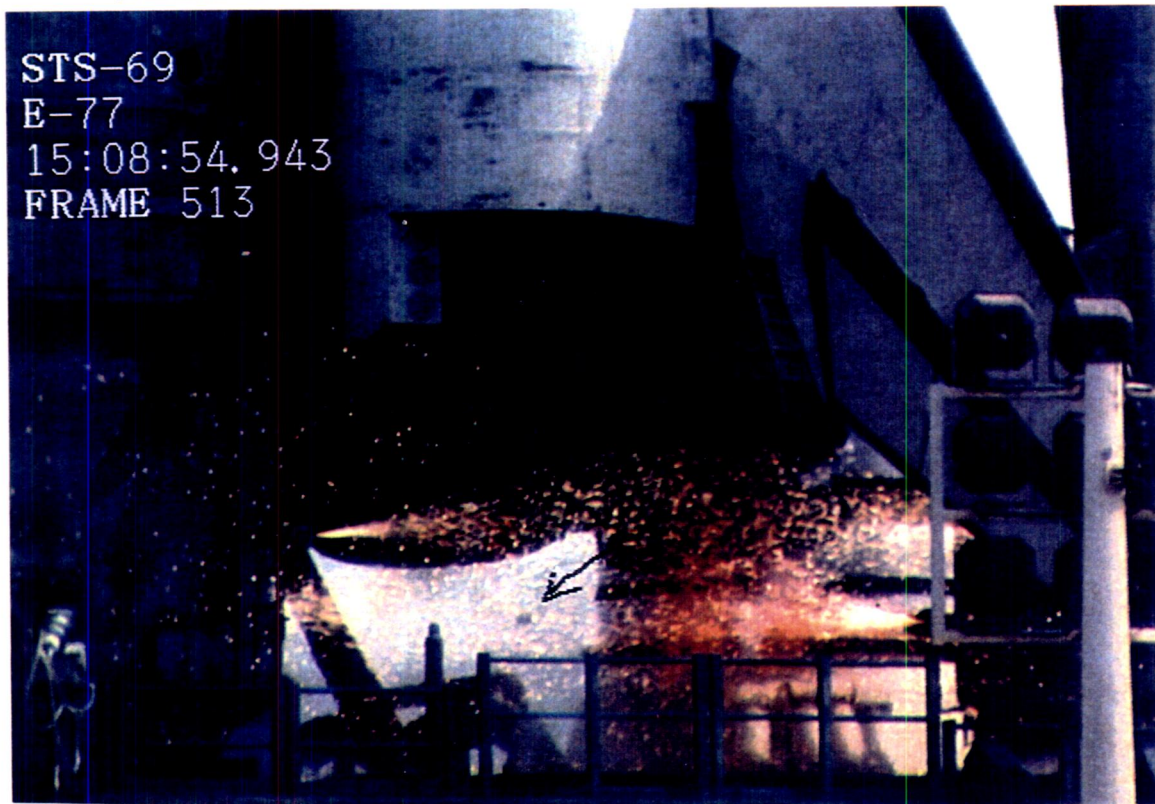
Figure 2.1.2.4 A Single Dark Piece of Debris seen Under SSME #2 at T-5.1 Seconds

A single dark piece of debris, probably a piece of ice, was first seen under SSME #2 and fell aft. No follow-up action was requested.

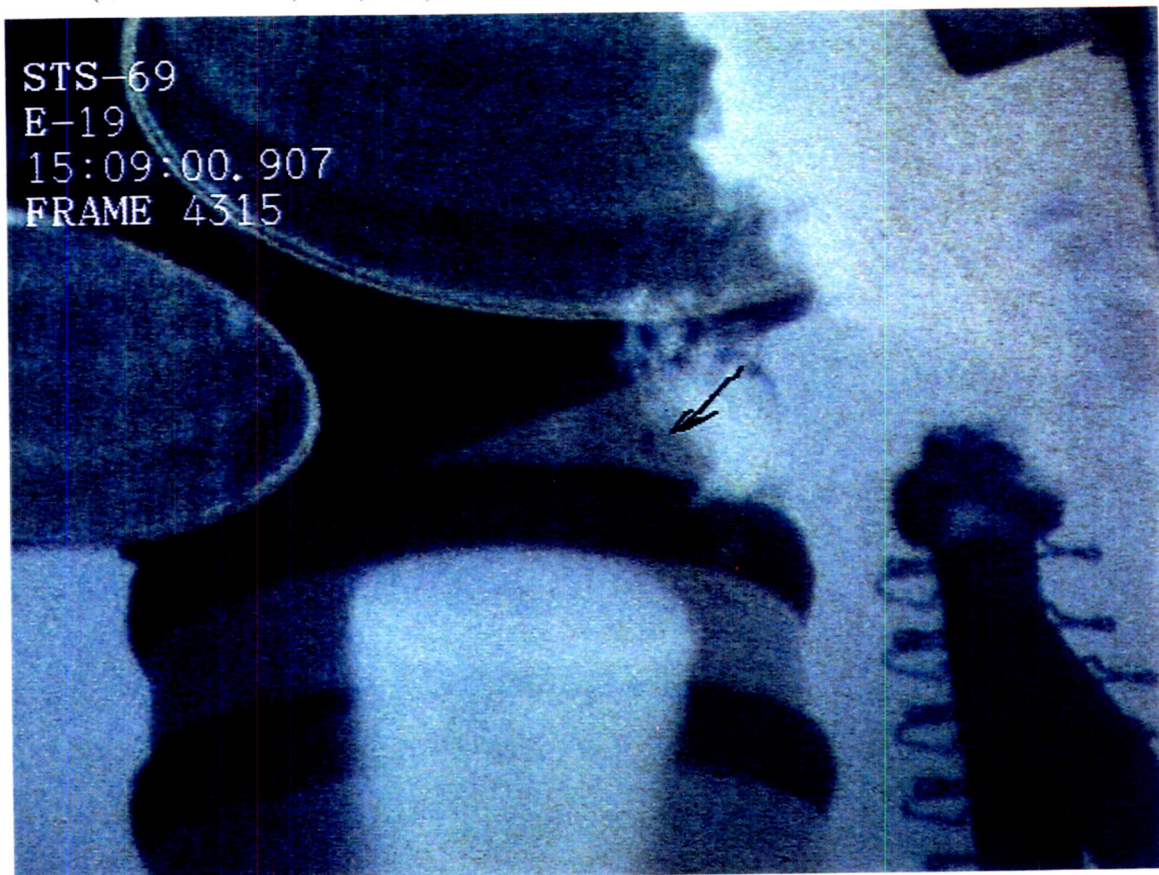
Figure 2.1.3.1 A Single Dark Piece of Debris seen Under SSME #3 at 1 Second MET

A single dark piece of debris was first seen under SSME #3 and fell aft. This piece of debris was first seen under SSME#2 on film item E77. KSC believes that this debris may be a 6-inch long by 2-inch wide gap filler found missing from the hinge line between SSME #2 and #3 during the STS-69 Orbiter Post Landing Inspection Debris Assessment. No follow-up action was requested.

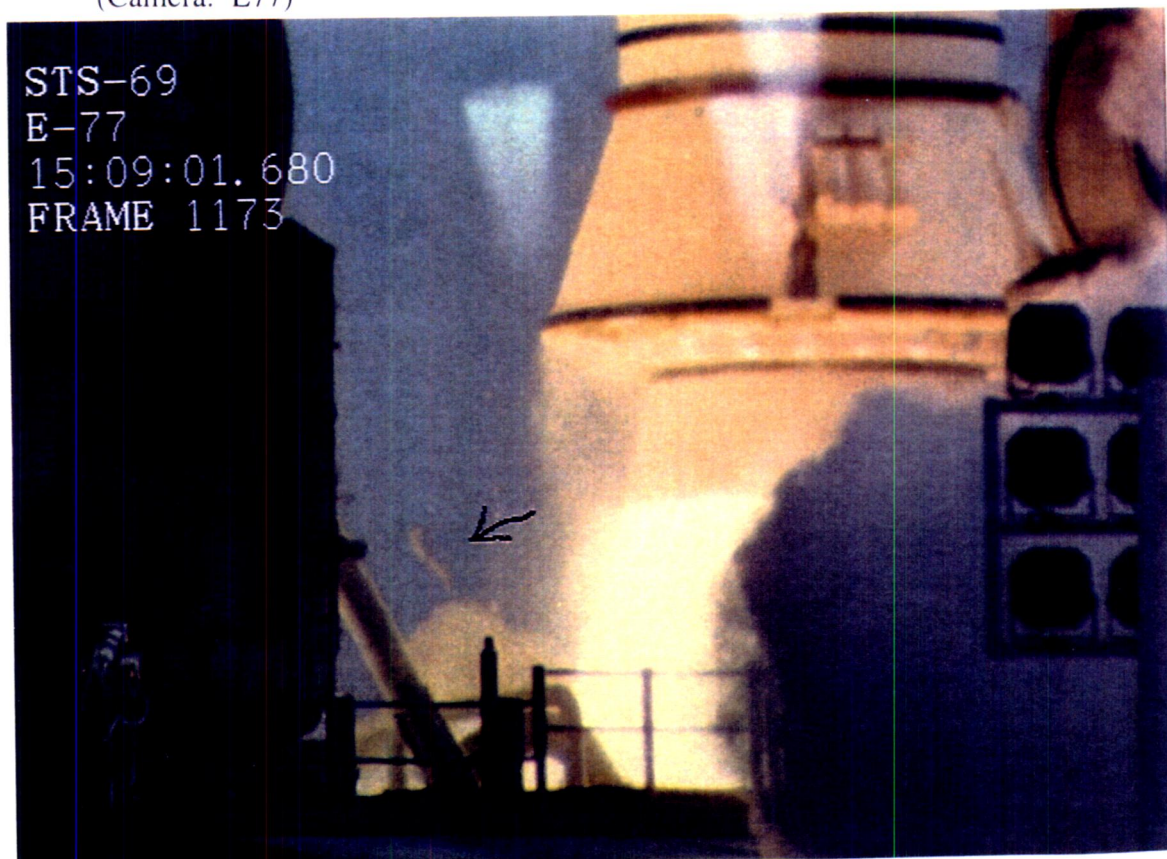
Figure 2.1.3.3 A Single Light Colored Rope-like Piece of Debris seen Coming from the RSRB Plume at 1.7 Seconds MET

A single light colored rope-like, flexible piece of debris was seen coming from the RSRB plume at 1.7 seconds MET. The debris was seen moving towards the LO2 TSM T-0 tower before it was lost from view. No follow-up action was requested.

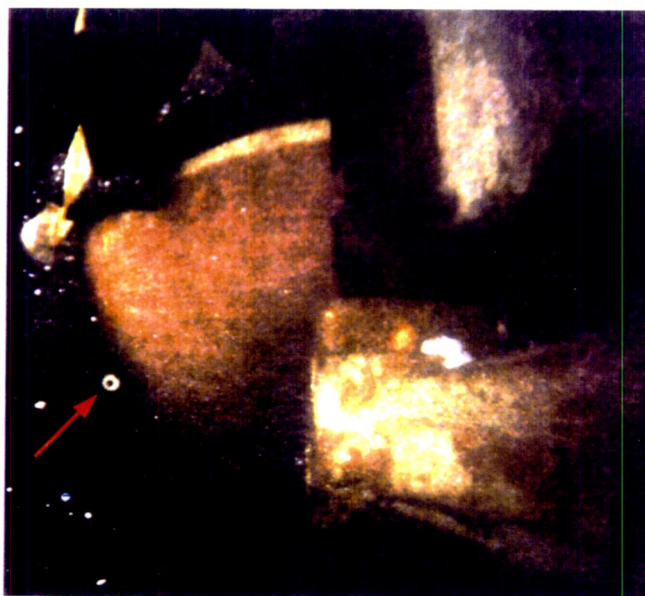
Figure 2.4.2 (A) Unidentified Circular Debris Object seen on the 16 mm (5 mm lens) Umbilical Well Film

An unknown highly reflective, thin, circular object with a circular hole in the center was seen near the electric cable tray and tumbled away from the Shuttle on the 16 mm umbilical well films. A phototheodolite analysis was used to measure the size and motion of the debris. This method uses the images of the debris from the two 16 mm umbilical cameras. The position of the debris relative to the cameras was calculated assuming that the cameras had the same time interval

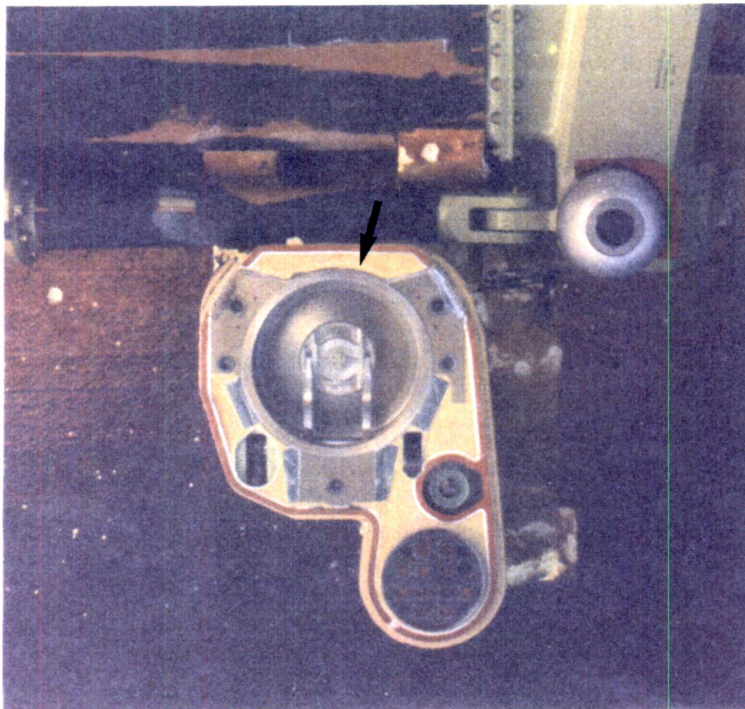
Figure 2.4.2 (B) Missing Lightning Contact Strip at the 12 o'clock Position Forward of the LO2 17 Inch Line Orifice.

The lightning contact strip at the 12 o'clock position forward of the LO2 17 inch line orifice is missing. LO2 umbilical lightning contact strip(s) were noted to be missing on STS-57, STS-58, STS-65, STS-66, STS-71 and other previous mission umbilical well films. Missing lightning contact strips were covered on a previous IFA.

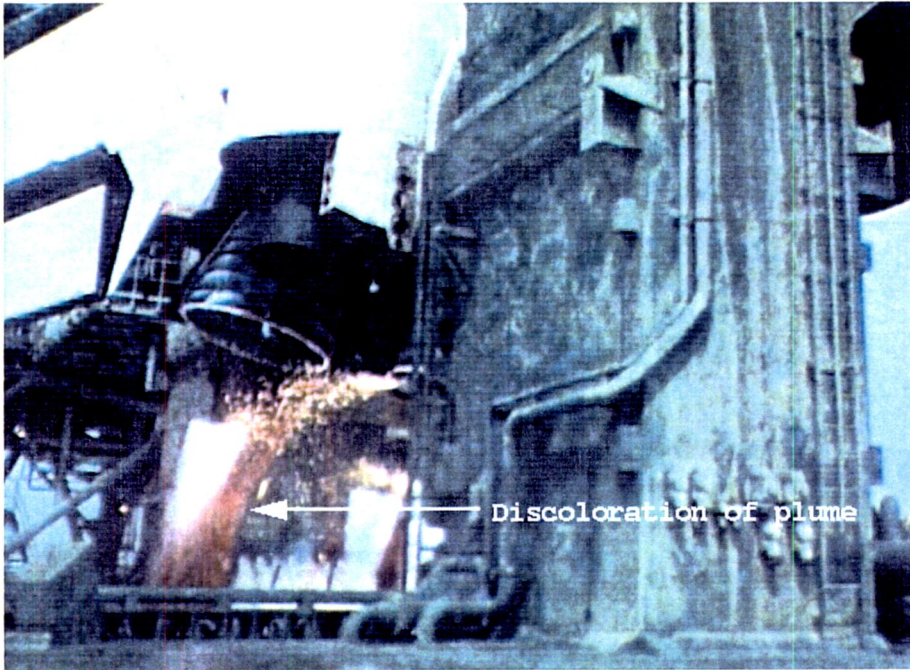
Figure 1 Orange discoloration in SSME #1 plume

At approximately T-1.5 seconds MET, the plume in SSME #1 was discolored orange for approximately 10 milliseconds. Figure 1 is a film frame from camera E-2 showing the discoloration.
